MERTON COLLEGE CHAPEL, OXFORD, OXI 4JD
QUINQUENNIAL INSPECTION REPORT 2022
ISSUE 01
FEBRUARY 2022

Survey prepared by: Alex Jeremy, RIBA AABC
Purcell Architecture Limited

Dates of inspection: 9th November 2021,
23rd November 2021

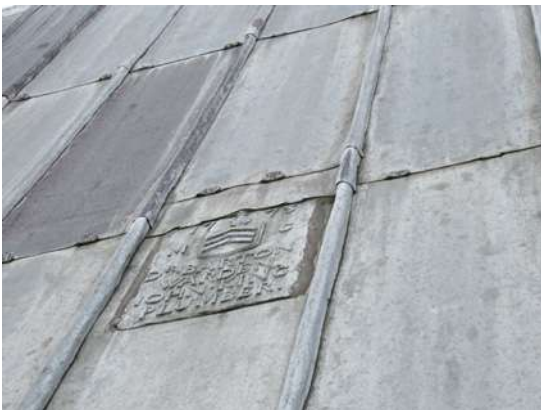
Fig. 5 Choir roof north slope

Element		Condition
EI External & Roofs		
EI.1 Roof Coverings And Gutters		
EI.1.1 Choir – North Slope	Leaded covering with date 1773.	The condition of the leadwork is fair. Some poor-quality repairs have been made in the past – see figs. 5 & 6
	There are four separate sheets between ridge and gutter. The size of the individual sheets is considerably greater than recommended, being about 2.6m in length. It was reported that the lead sheets slip occasionally.	The flashings which cover the junction between the east gable and the lead sheeted roof appear insecurely fixed – see fig. 7
	It appears that the last bay next to the east end has been replaced, possibly at the same time as external masonry repairs.	See fig. 7
	Catch pit to each parapet outlet and hopper. Gutter ‘duck’ boards to lead-lined parapet gutter.	Hoppers appear in good condition – see fig. 8. Some build-up of debris to catch pits – see fig. 9. Some build-up of debris to gutter ‘duck’ boards – see fig. 10.

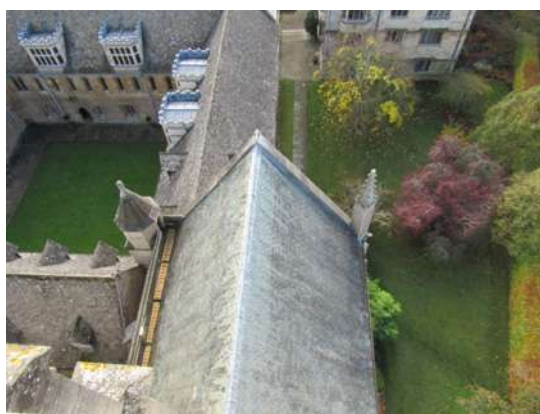
Fig. 16 South transept east & west slopes

Element	Condition
El.1.4	Roof is covered in Westmoreland slates	All appear in good condition – see fig. 16
South Transept – West Slope	Roof falls to an eaves gutter sat on string course which feeds to lead hoppers and downpipes	Appears in good condition – see figs. 16 & 27
El.1.5	The roof is covered with Westmoreland slates with lead flashings.	Slates are in fair condition – see figs. 19-21. There are about 20 slates which are either missing, displaced or tagged in position with metal strips. Flashings appear in good condition – see fig. 21.
North Transept – East Slope	Roof falls to a lead-lined parapet gutter.	Gutters appear in fair condition; however gutter 'duck' boards show signs of decay and cause considerable build-up of debris – see fig. 20.
	Stone spirelet to north-east corner	In good condition – see fig. 22
El.1.6	The roof is covered with Westmoreland slates. It falls to a lead-lined parapet gutter.	Gutter not accessible, however, slates appear in fair condition with likely some slipped slates. Gutter likely has some build-up of debris – see fig. 18

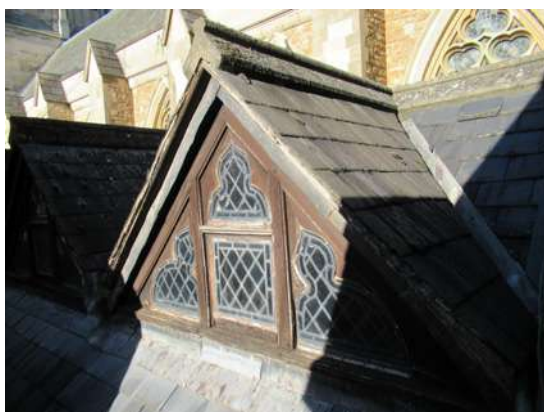
Fig. 35 Sacristy roof south slope

Element	Condition
EI.1.9 Sacristy – South Slope	There are three gablets on the upper part of the roof containing triangular windows with leaded lights. The lower roofs fall to a lead-lined gutter.	<p>In overall fair condition – see figs. 35 & 36. This slope is noticeably more decayed than the north side.</p> <p>There are some slipped slates, signs of timber decay and perished mortar at the junction of the slates with the ends of the gablets – see fig. 40.</p> <p>The leaded lights have some distortion, though less than on the north side – see figs. 35 & 36.</p> <p>The lead-lined catch pits are not easily accessible except with ladders and are prone to blockage – see fig. 37. Lead flashings appear in good order for the most part – see fig. 39 – but with some considerable areas of decay to rainwater management installation – see fig. 38.</p>
EI.2 Stone Staircases		
	A spiral stone staircase is attached to the south-east corner of the south transept. It rises from ground level to the level of the main roof. A further spiral stone staircase at the north-east corner of the tower rises from this level, passing the bell chamber to the tower roof level. The same staircase provides access to the parapet gutter which runs along the north side of the choir roof.	<p>The stone staircases are in good condition for their age – see fig. 41</p> <p>Rope handrails have been installed since 2000 to improve their safety.</p> <p>Routine maintenance is required to keep them swept clean and clear of any debris.</p>

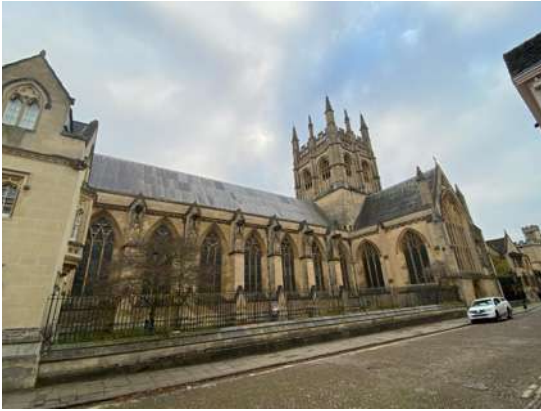
Fig. 43 Choir North Elevation

Element	Condition
EI.7 External Masonry		
EI.7.1 Choir: North Elevation	This façade faces the burial ground and Merton Street and is adjacent to the North Transept: east elevation.	See fig. 43 and fig. 44
	The Burial Ground consists of lawn with shrubs to north margin and cobbled setts to buttress recesses, separated from lawn by a drainage channel.	See External Areas.
	Façade of coursed ashlar limestone to upper levels and plinth with coursed rough-faced limestone to lower, separated by copings and string course.	Stonework to the façade appears in good condition with some localised weathering and staining from water run-off, particularly to the cills, parapet copings, and string courses. Some poor pointing is present to rough-faced stonework – see fig. 45
	There are 7 arch-headed windows with stone tracery; the 3 windows to the east and west of the central window repeat in pattern; all a variation on trefoil design. Grotesque entablature – likely re-carved – is over each window bay beneath the string course.	See also windows. All are in good condition with multiple instances of recent stonework repairs to the lower window reveals – see fig. 44. Entablature is in good condition, however some missing – see fig. 46. Cills and lower string courses are discoloured from weathering but appear in good to fair condition.

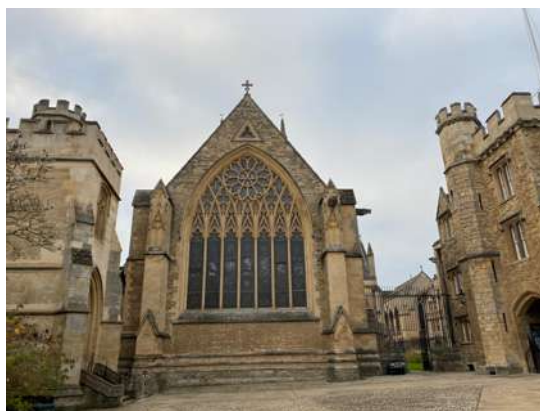
Fig. 50 Choir east elevation

Element	Condition
EI.7.2 Choir: East Elevation	This façade faces the Front Quad and is adjacent to the entrance to the Burial Ground and Sacristy: east elevation.	See fig. 50
	The front quad consists of cobble setts with inset stone flags.	See External Areas.
	Façade of coursed rough-faced limestone to upper - with inset kneelers and capping – and plinth lower. Coursed ashlar limestone to lower string courses.	Stonework to the façade appears in good condition with some localised weathering and staining from water run-off, particularly to cills and string courses. There are some open joints to ashlar and rough-faced stonework – see fig. 51.
	The principal east window comprises fine stone tracery and inset rose window to apex with trefoil window over.	See also windows. In good condition with recent repairs and cleaning evident. Cills and lower string courses show signs of discolouration from weathering but appear in fair to good condition. Gargoyle appears in fair order but is significantly discoloured from weathering – see fig.50.
